# Fire testing of concrete beams with fibre reinforced plastic rebar

The behaviour of glass fibre reinforced polymer (GFRP) rebar reinforced concrete beams when exposed to fire is presented in this paper. The experimental programme involved fire tests based on British Standard 476 on two full-scale GFRP rebar reinforced concrete beams with dimensions in cross-section 350 mm×400 mm and 4400 mm total length with a span length of 4250 mm. The beams were designed and constructed according to Eurocode 2 and ACI-440. The purpose of this work was to evaluate the fire resistance of the GFRP reinforced concrete (RC) beams. GFRP rebars with thermoset resin were used for reinforcing beam 1 and GFRP rebars manufactured with thermoplastic resin were used for reinforcing beam 2. Shear reinforcement for beam 1 was GFRP stirrups and for beam 2 steel stirrups were used. Degradation in the flexural capacity due to fire was evaluated and compared. In this study, loaded heating tests were implemented with the aim of collecting basic data for the validation of a model presented in preceding papers by the authors.

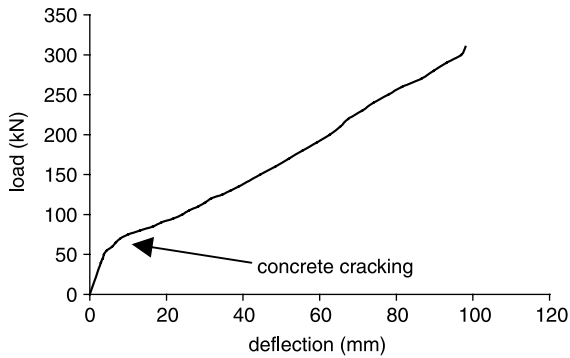
Fig. 3. Load–deflection curve for control beam.

To evaluate the flexural behaviour of the proposed beam, a flexural six point bending test was carried out at room temperature. The beam was subjected to increasing load in increments of 5–10 kN, until final failure. The load was stopped at each increment for 2 min for observation. Load was applied with a hydraulic jack at four points along the beam. Vertical deflection was measured at mid-span using a linear voltage deflection transducer (LVDT). The loading of the beam resulted in the load–deflection curve shown in Fig. 3. The initial linear relationship between load and deflection became non-linear after an applied load of approximately 60 kN. This was accompanied by the onset of cracking in the concrete in tension face. The code of practice specifies a maximum deflection allowable of  $L/250$ , which in this case is 17.0 mm, and this was exceeded at a

load of 90 kN. A load of 40 kN was selected for the fire test as being below the concrete cracking threshold.

The load was increased to a maximum of 310 kN, which produced a deflection in the beam of 98 mm. After unloading, the beam moved back to the same position as prior to loading. This shows that recovery of the beam is not impeded by plastic deformation of the rebar as would be the case with steel reinforced beams.

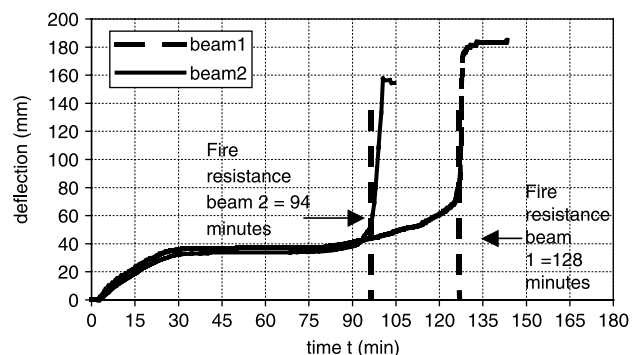
Fig. 7. Heating time–deflection curves for beam 1 and beam 2.

The sequence of events observed during the fire test on each beam are listed chronologically in Tables 4 and 5, and deflection–time curves are shown in Fig. 7. A slow but steady increase in beam deflection was recorded from outset of the test, but this settled down and the beams were effectively stable after approximately 30 min; at this time the only observed effects were small amount of concrete spalling from the corner of the beams. Cracking in the concrete became evident in both beams after about 75–80 min, which was accompanied by flaming from the crack regions. The beams exhibited an increase in deflection which was identified as failure after 94 min for beam 2 and 128 min for beam 1. The appearance of the beams after failure and cooling to room temperature is shown in Figs. 8 and 9. The mode of failure of beam is via flexural-shear

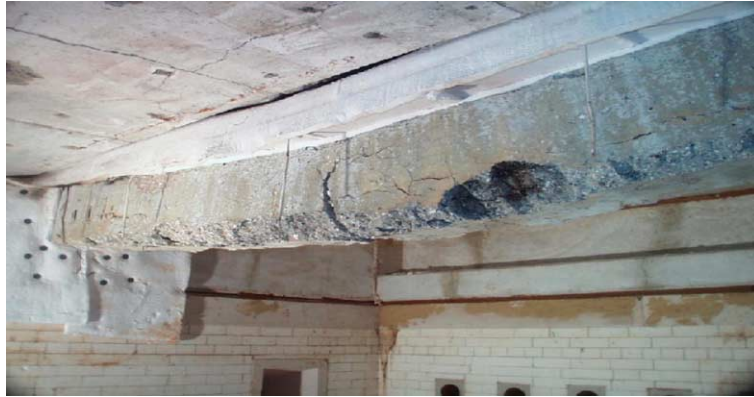
Fig. 8. Rupture at the mid-span of the concrete in beam 1 after fire.

cracks and spalling of the concrete. After the fire testing, the beams were removed from the furnace and it was observed that beam 1 was splitting into two.

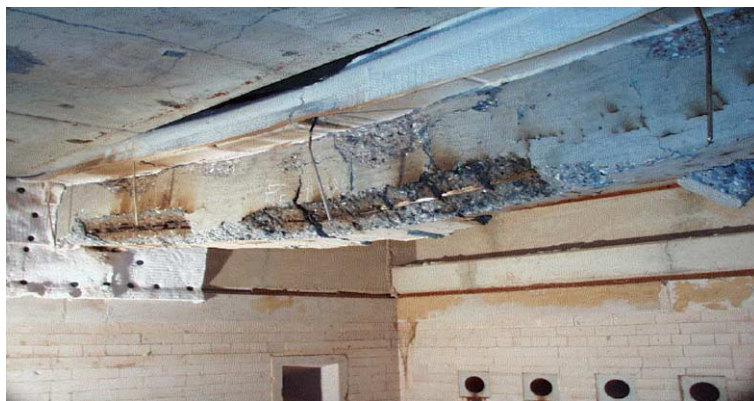
Fig. 9. Failure of beam 2 after fire test inside the furnace shows some flexural cracks and rupture in the main reinforcement.

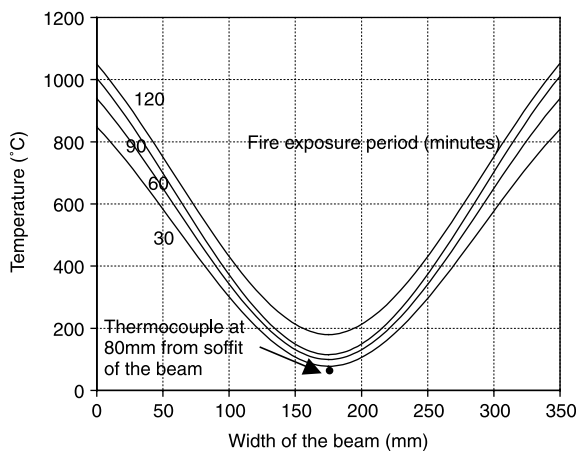
Fig. 10. Temperature profile obtained from the average thermocouples reading in the cross-section of the beam 1, 80 mm from bottom of the beam for different fire exposure periods. The temperature of each side of the beam is an average reading from TC's in furnace on the each side of the beam.

Fig. 10 depicts the temperatures measured at the mid-span of the beam in position B, 80 mm from bottom of the beam. The temperature increases with time. Fig. 11 shows the maximum temperature measured at the rebar at each time interval. Fig. 12 shows the average temperature at the stirrups. The data excludes 2–3 readings, which showed sudden, erratic and abrupt changes. This may be attributed to a possible shorting of a PTFE coated wire and the record showing temperature at a location other than the end of the thermocouple.
